Technical Report

**CORROSION OF MATERIALS
IN HYDROSPACE**

U. S. NAVAL CIVIL ENGINEERING LABORATORY
Port Hueneme, California

Technical Report R-504

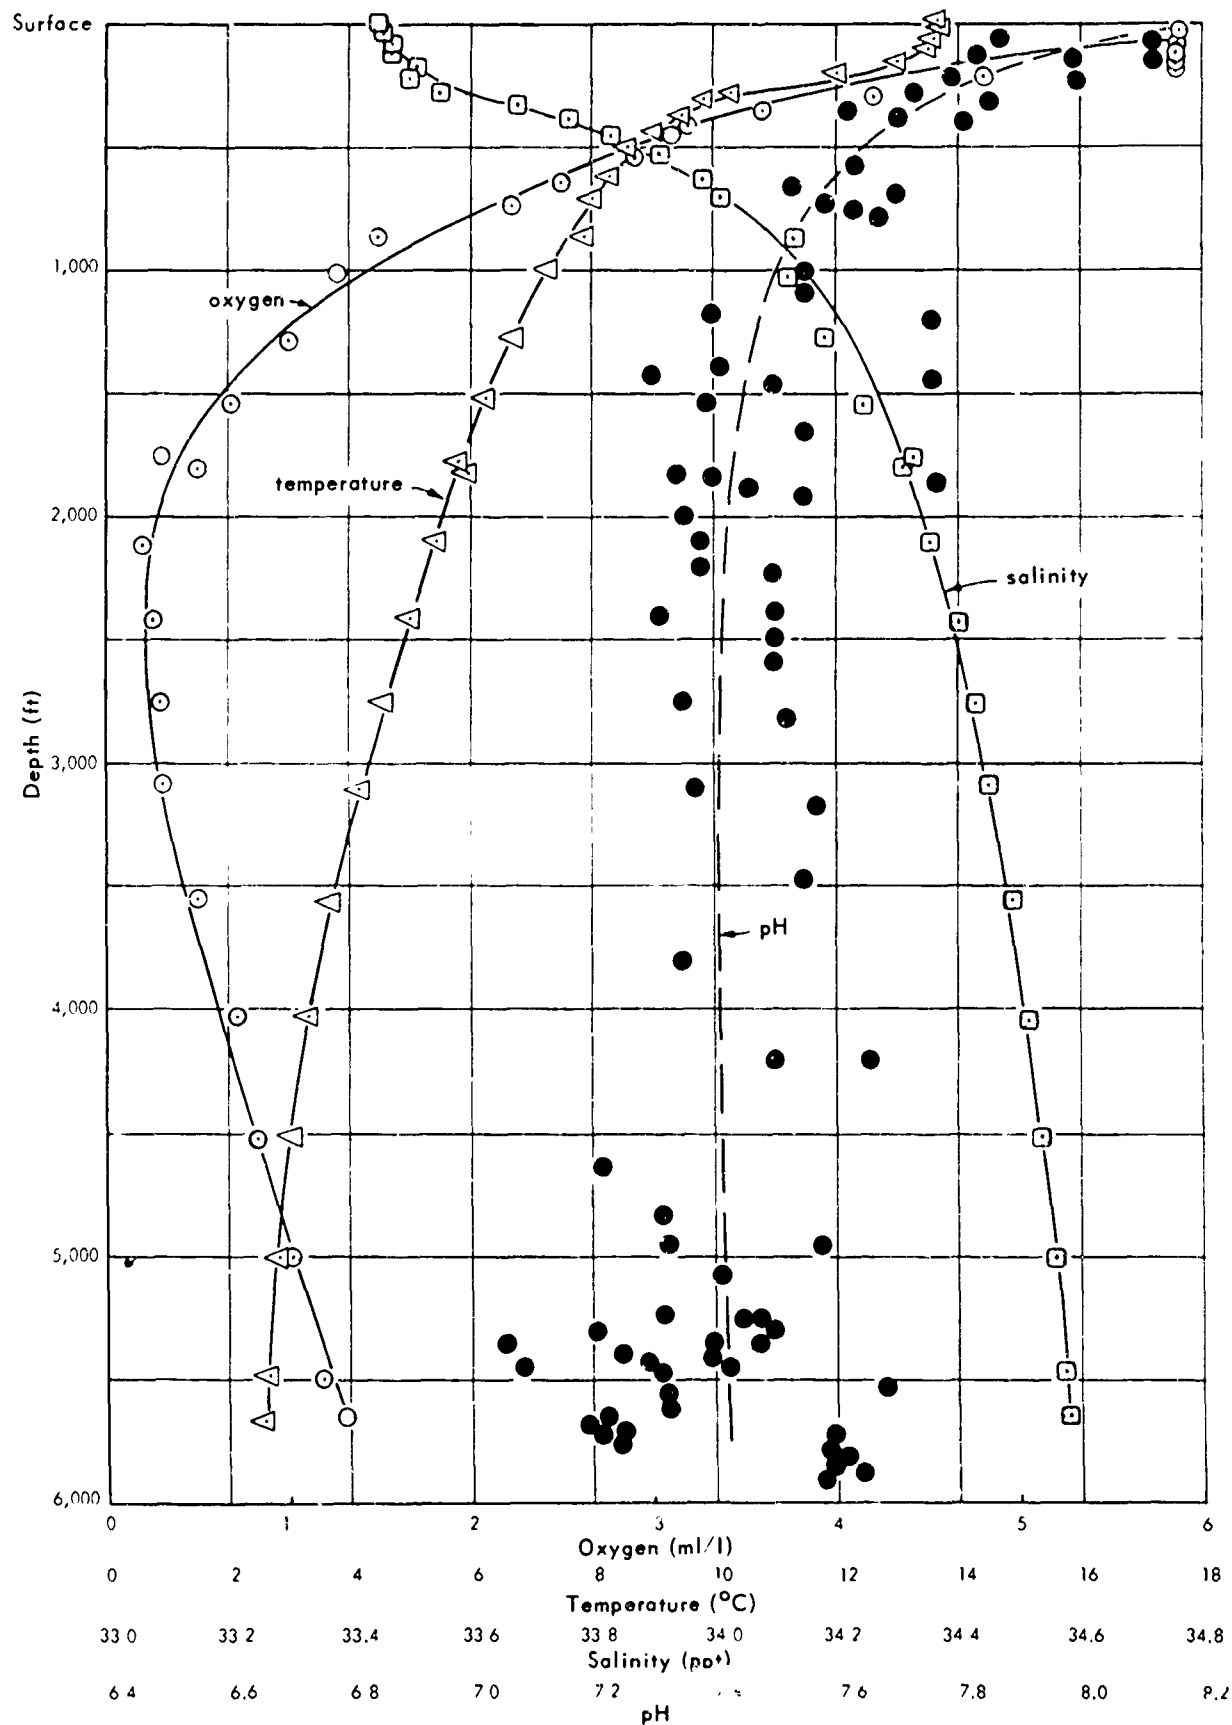
Figure 2. Oceanographic data from a location about 5 miles northwest of STU I-1 site (except for the pH curve, which represents data from the vicinity of STU I-1).

The complete oceanographic data at this location on 12 January 1962, as reported by Scripps Institution of Oceanography is shown in Figure 2.

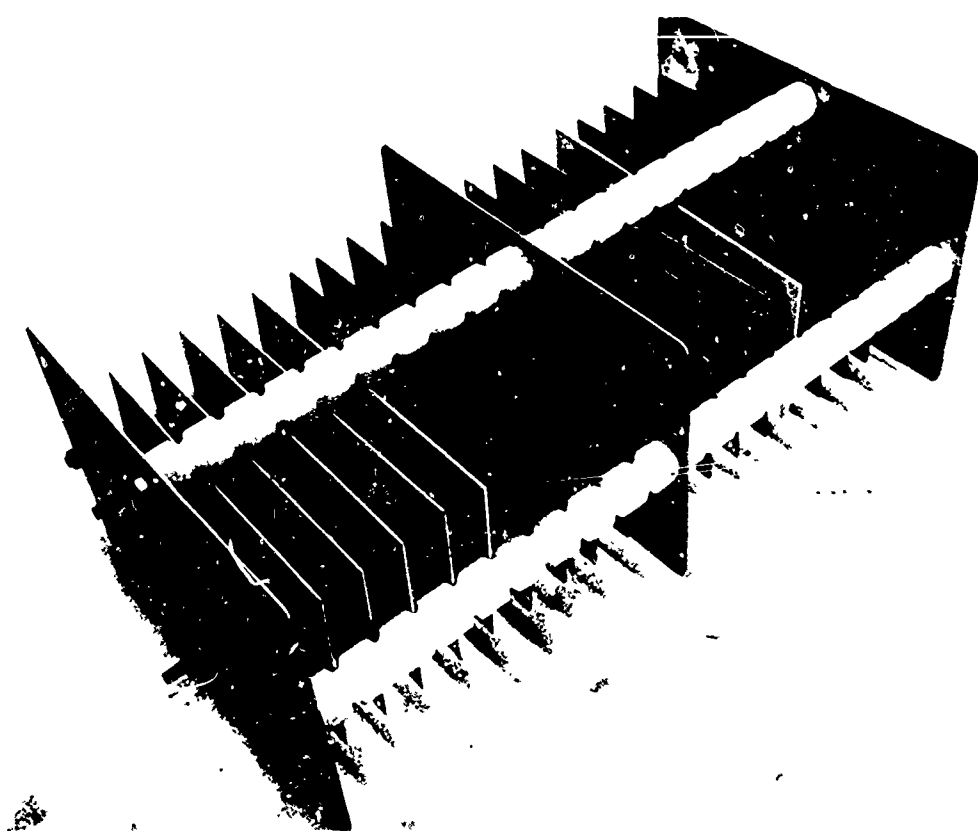
Figure 3. Exposure rack for 6 x 12-inch specimens.

The 6 x 12-inch specimens were held in the type of rack shown in Figure 3. The specimens were held in place by four molded, grooved polyethylene insulators and were separated from each other by 1 inch. The specimens were thus electrically insulated from each other and from contact with all metallic parts of the rack and structure, thereby precluding the possibility of galvanic corrosion. The center dividers and end plates were either aluminum alloy 5086-H32 or titanium alloy 75-A. The rods through the insulators were nickel-copper alloy 400 fastened with nuts and washers of the same composition. In all cases polyvinyl chloride (PVC) washers were used between the metal washer and the end plates. The two longer rods (those on the sides) were used to fasten the racks on the STU structures.

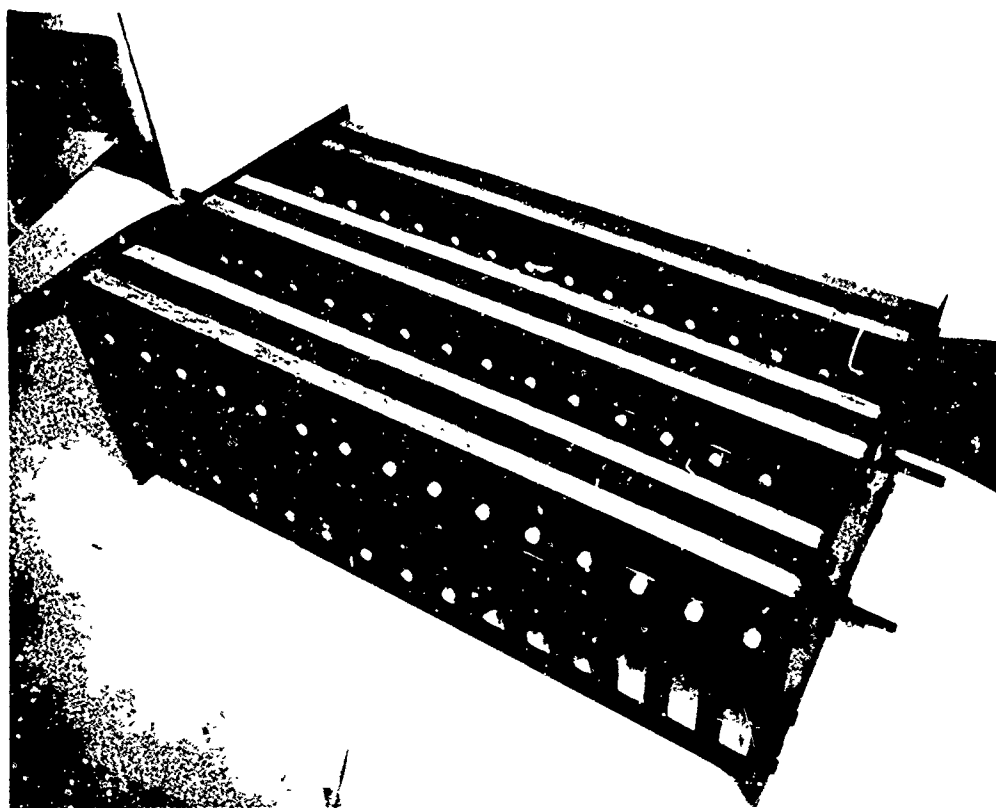
Figure 4. Exposure rack for 1 x 6-inch specimens.

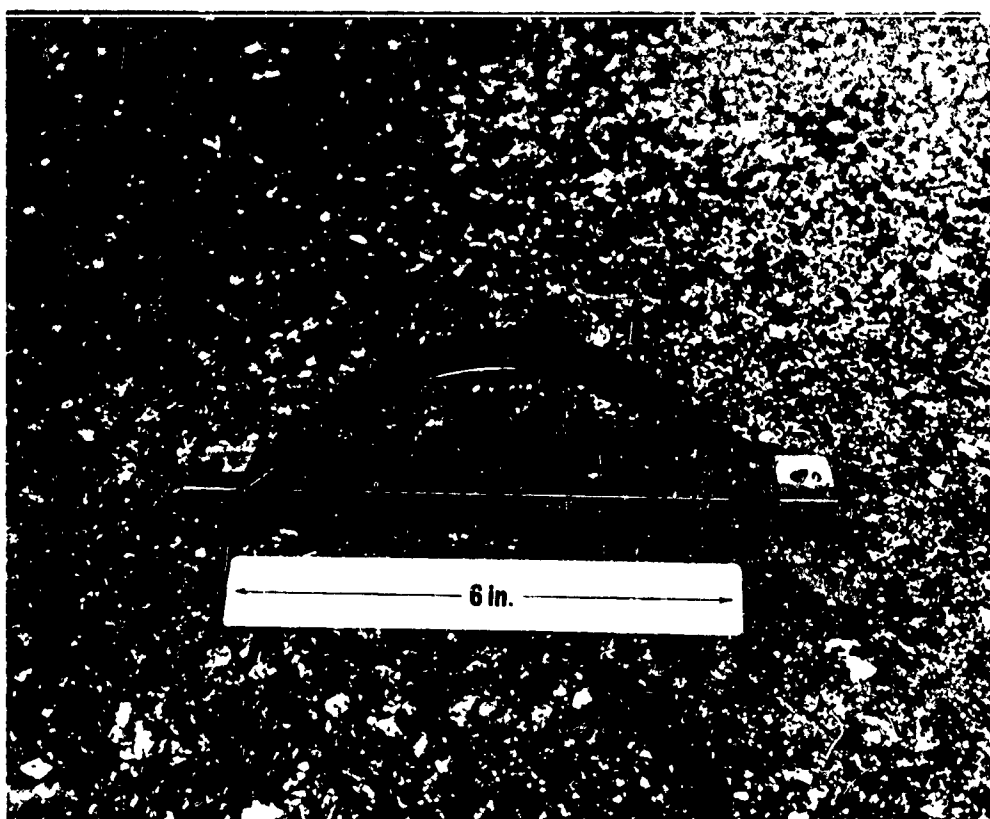
Figure 5. Jig for stress corrosion specimens.

Some of the first stress corrosion specimens were stressed by machining them to lengths calculated to produce the desired stress on the convex side when sprung into a jig with slots 7.00 inches apart (Figure 5). The ends of the jigs and specimens were coated with a water-impervious compound to prevent galvanic corrosion between the jig and the ends of the specimens. This method was later found to be unsatisfactory because of the crevice corrosion of the specimens occurring at the edges of the coating.

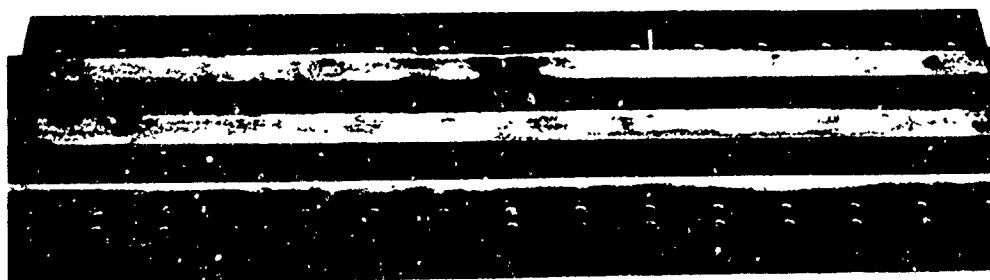
Figure 6. Four-point jig for stress corrosion specimens.

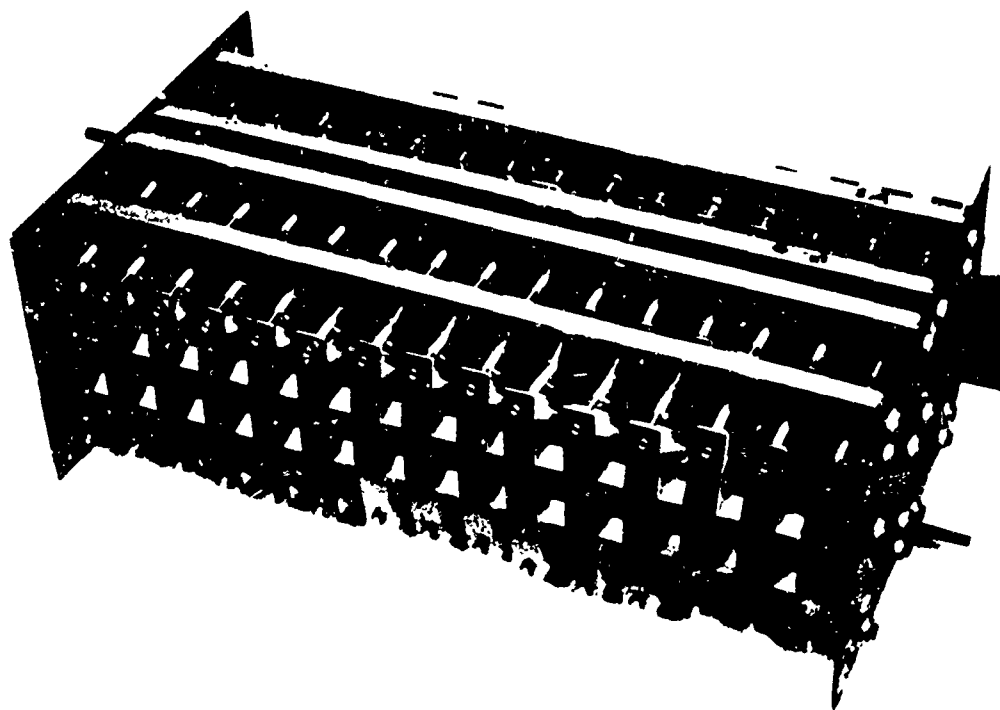
Figure 7. Stress corrosion rack.

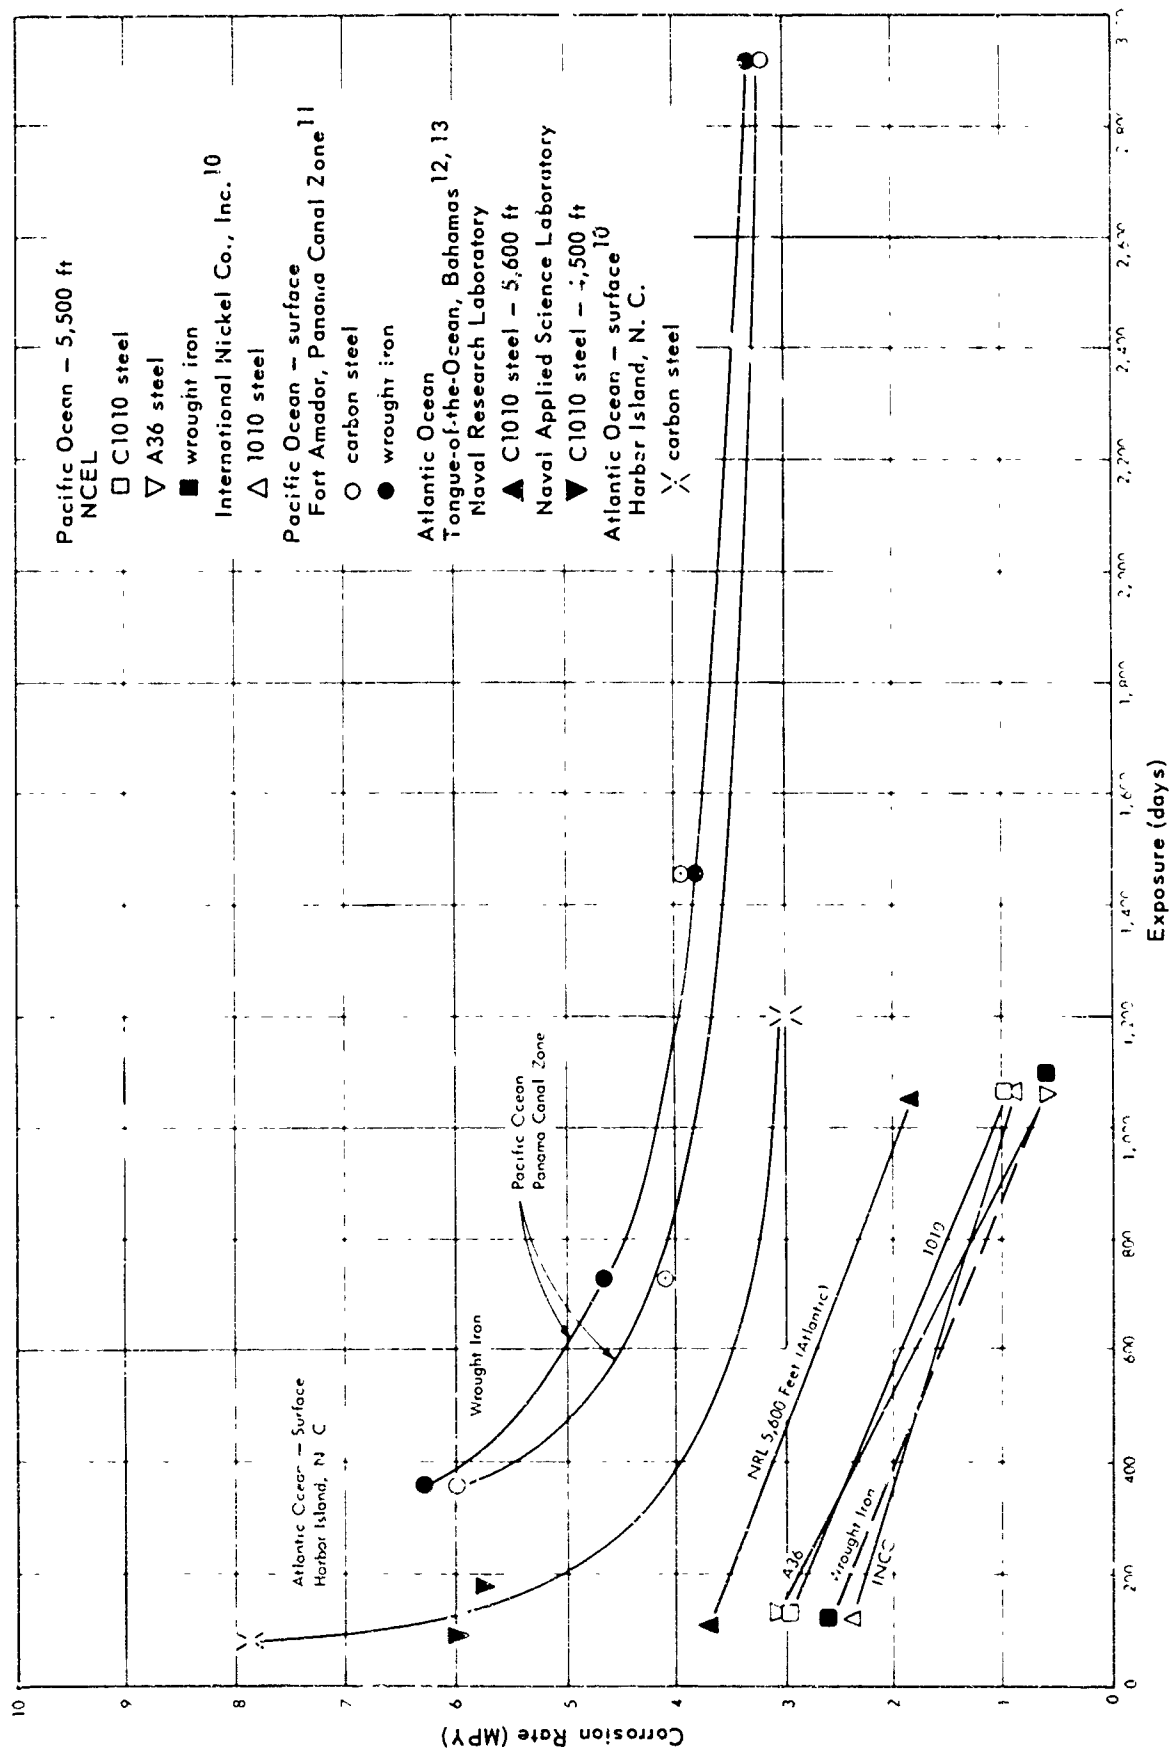
Figure 8. Corrosion rates of carbon steels in the Atlantic and Pacific Oceans at various depths.

Figure 8 shows a comparison of the corrosion rates of low-carbon steels immersed in the surface of the Atlantic Ocean at Harbor Island, North Carolina and in the Pacific Ocean at Fort Amador, Panama Canal Zone, with those at depths of from 5,300 feet to 5,640 feet (nominal 5,500 feet) in the Pacific Ocean and at depths of 4,500 feet and 5,600 feet in the Atlantic Ocean (Tongue-of-the-Ocean, Bahamas). The corrosion rates of steels at the surface in both the Atlantic and Pacific Oceans decrease rather rapidly with time and become constant after about 2 to 3 years of uninterrupted exposure. The fact that the initial corrosion rate after 1 year of exposure for the steel at Fort Amador is higher than that at Harbor Island is attributed to the difference in the average temperatures (27°C versus 21°C). (Theoretically, an increase of 10°C should cause the rate of a chemical reaction to be doubled.)

The corrosion rates of the steels (C1010 and A36) exposed at a nominal depth of 5,500 feet in the Pacific Ocean also decreased with time of exposure and were consistently lower than the surface corrosion rates. The corrosion rates at a depth of 5,500 feet in the Pacific Ocean were about one-third the rate of the steels at Harbor Island after about 3 years of exposure.

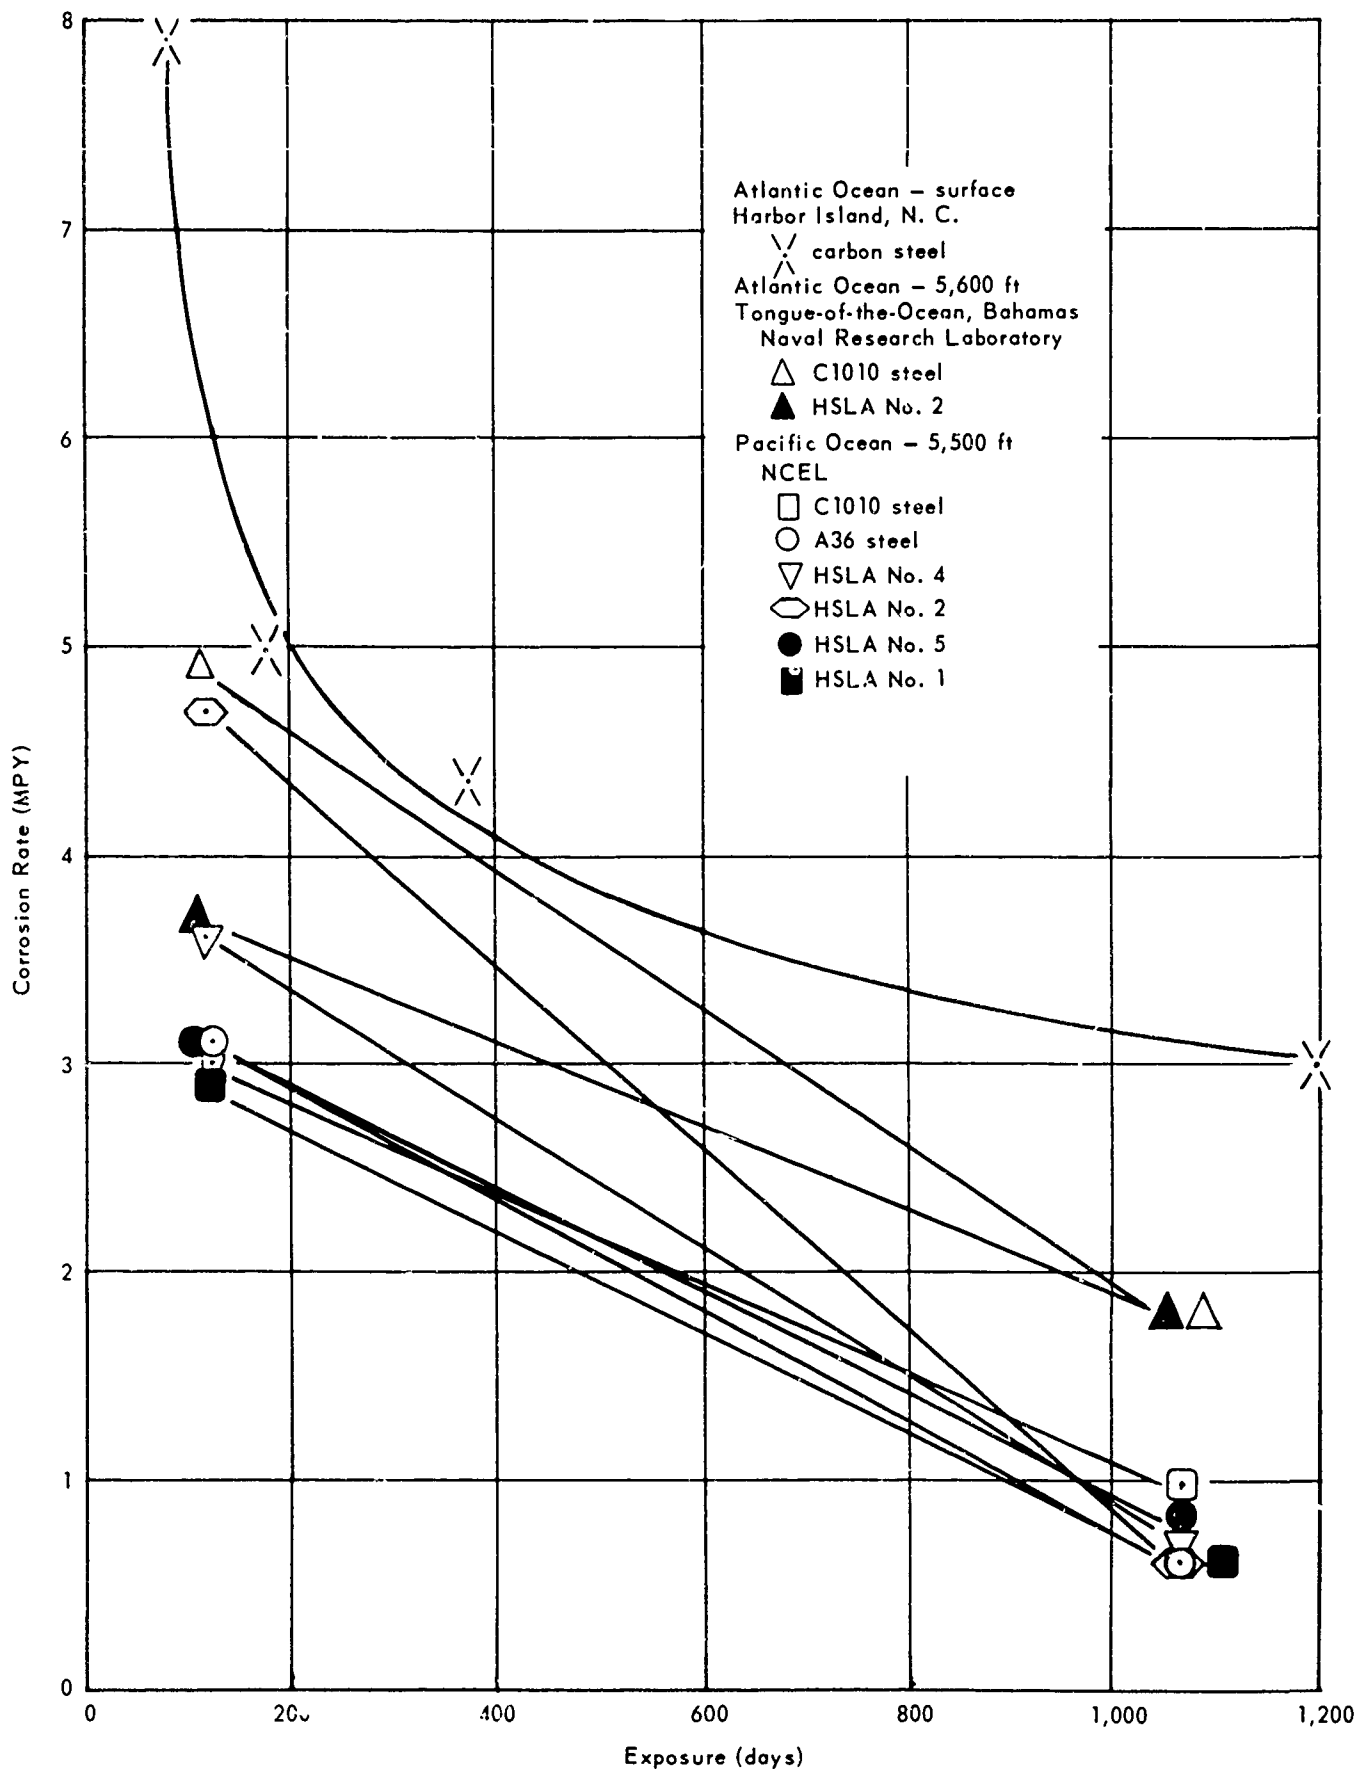
Figure 9. Corrosion rates of low alloy steels.

The corrosion rates of the low-alloy steels at a nominal depth of 5,500 feet, shown in Figure 9, compare very favorably with those of the carbon steels. Although there is a difference of about 2 MPY after 123 days of exposure, there is only a difference of 0.5 MPY after 1,064 days of exposure. For practical purposes, it can be stated that carbon steels, high-strength low-alloy steels, and low-alloy steels, after a short initial period of exposure, corrode at the same rate at a depth of about 5,500 feet at this particular site (STU I area) in the Pacific Ocean.

The data from a depth of 5,600 feet in the Atlantic Ocean¹³ are also plotted in Figure 9 for purposes of comparison. The corrosion rates of these two steels are also the same after 1,050 days of exposure, but are slightly higher than those in the Pacific Ocean.

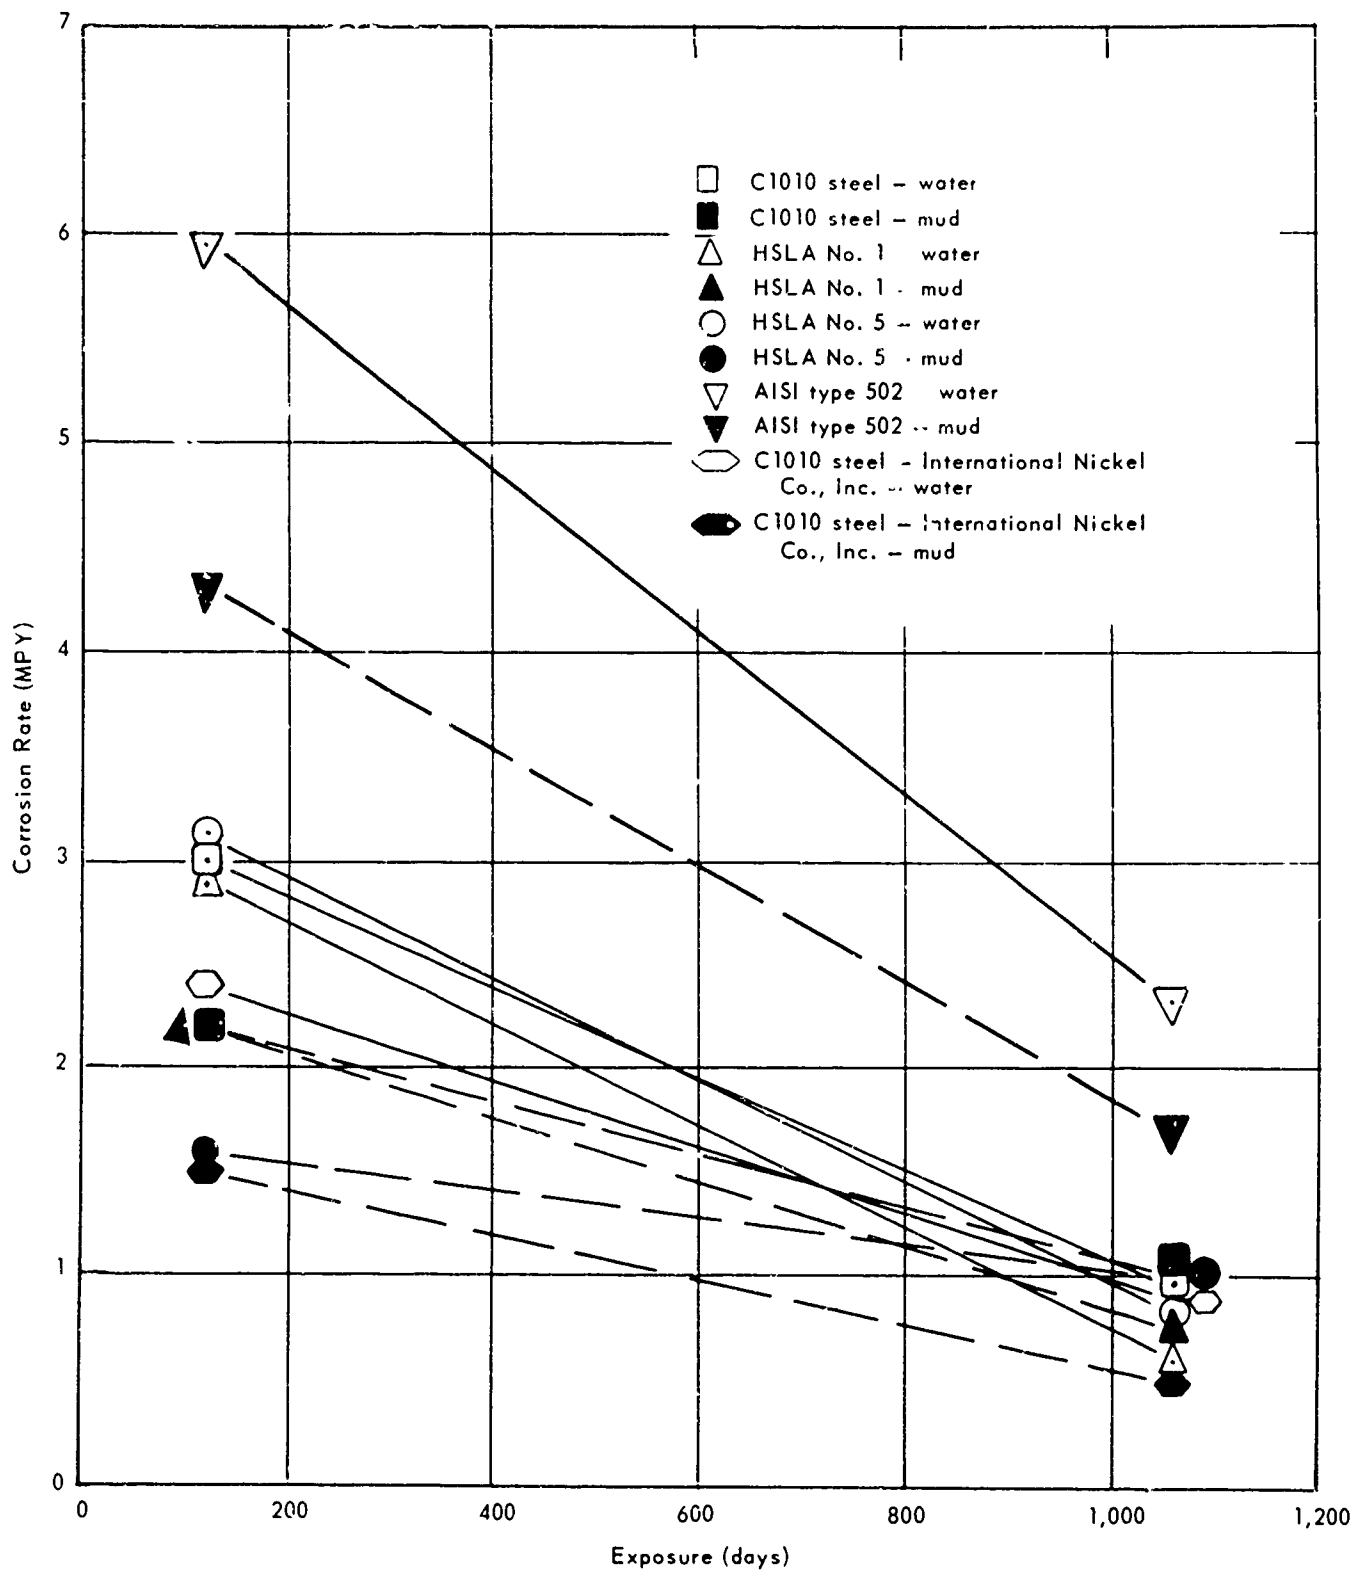
Figure 10. Corrosion of steels in water and partially embedded in bottom sediment.

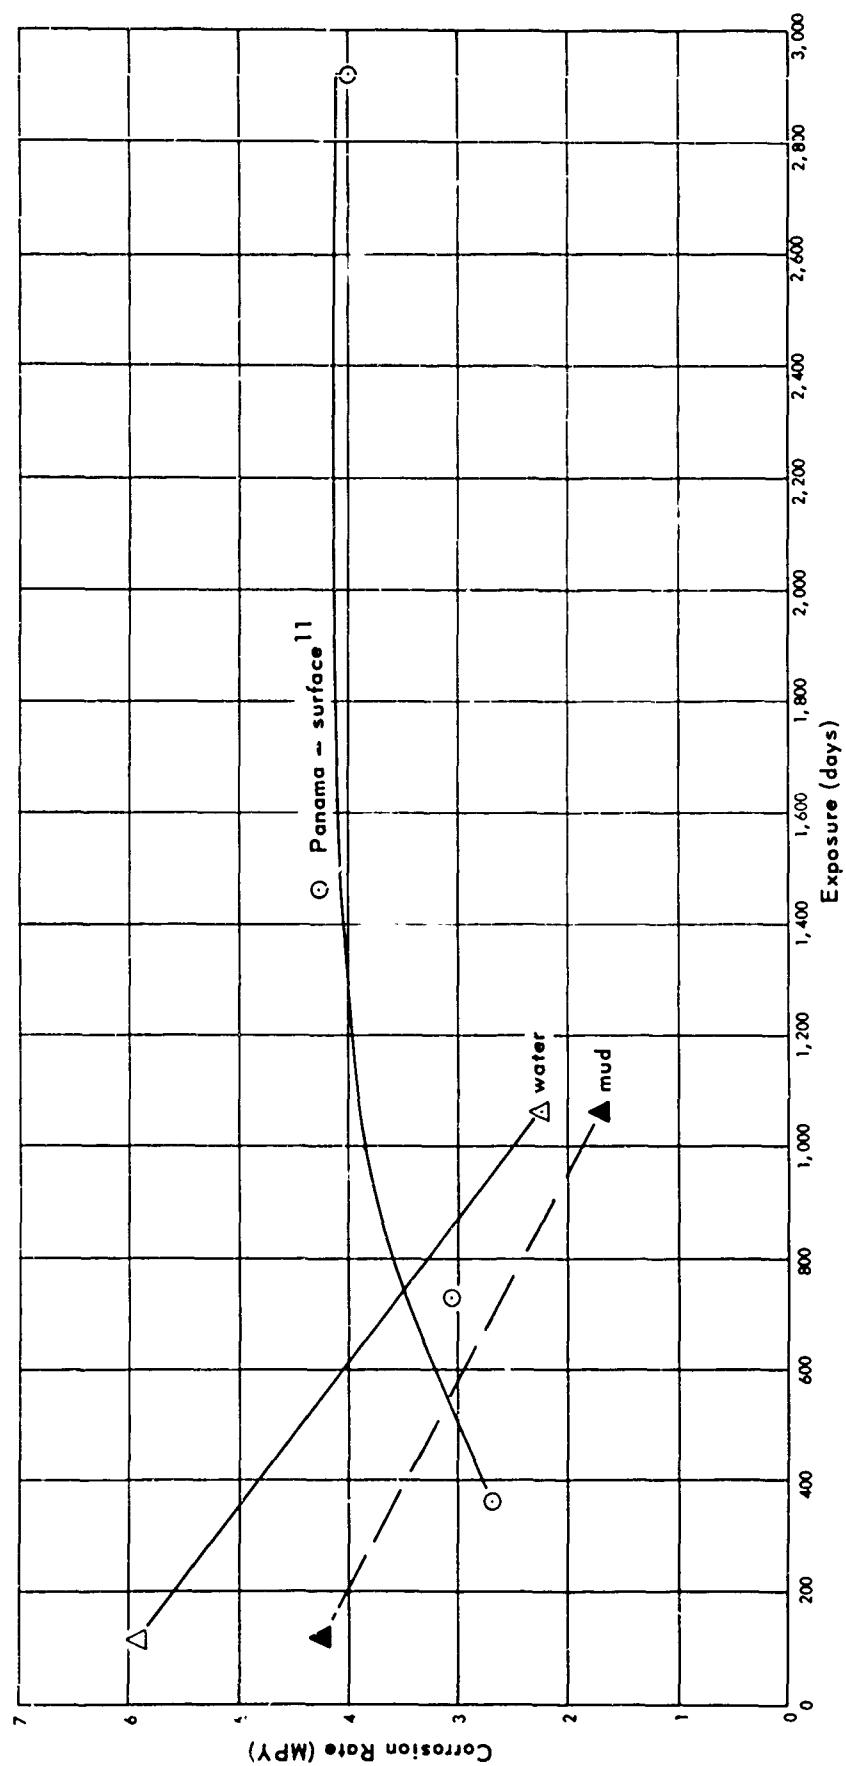
Figure 11. Comparison of corrosion of type 502 steel at a depth of 5,500 feet and at the surface of the Pacific Ocean.

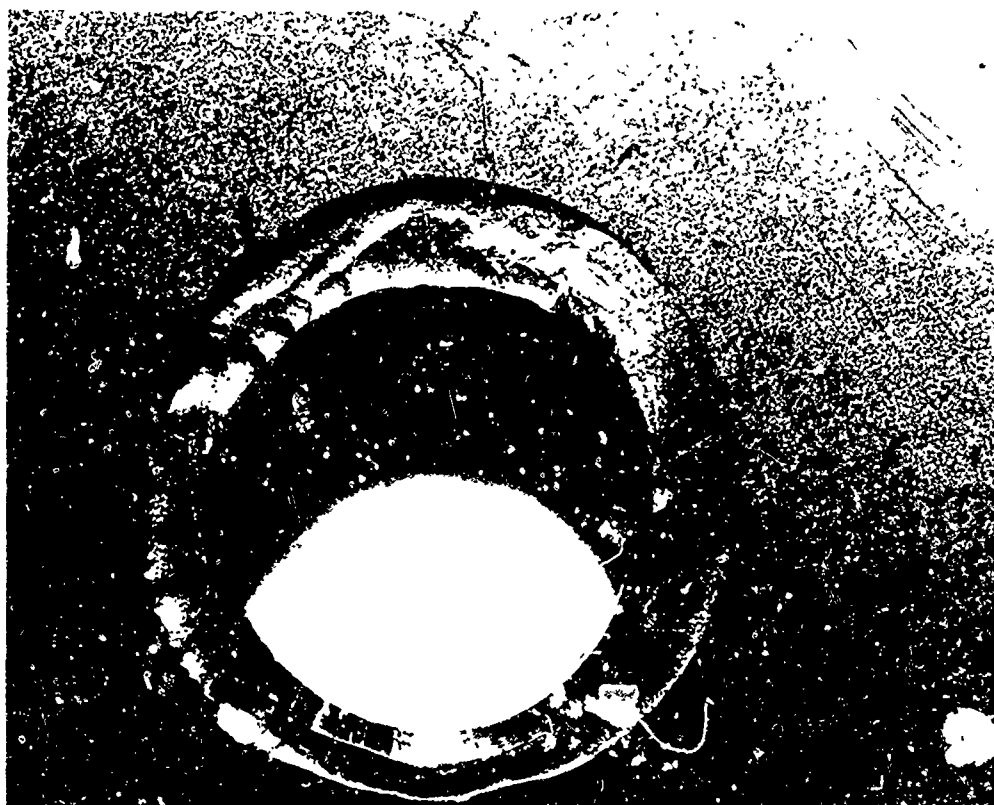
Figure 13 Crevice corrosion underneath head of nylon bolt on type 302 stainless steel (123 days at 5,640 feet).

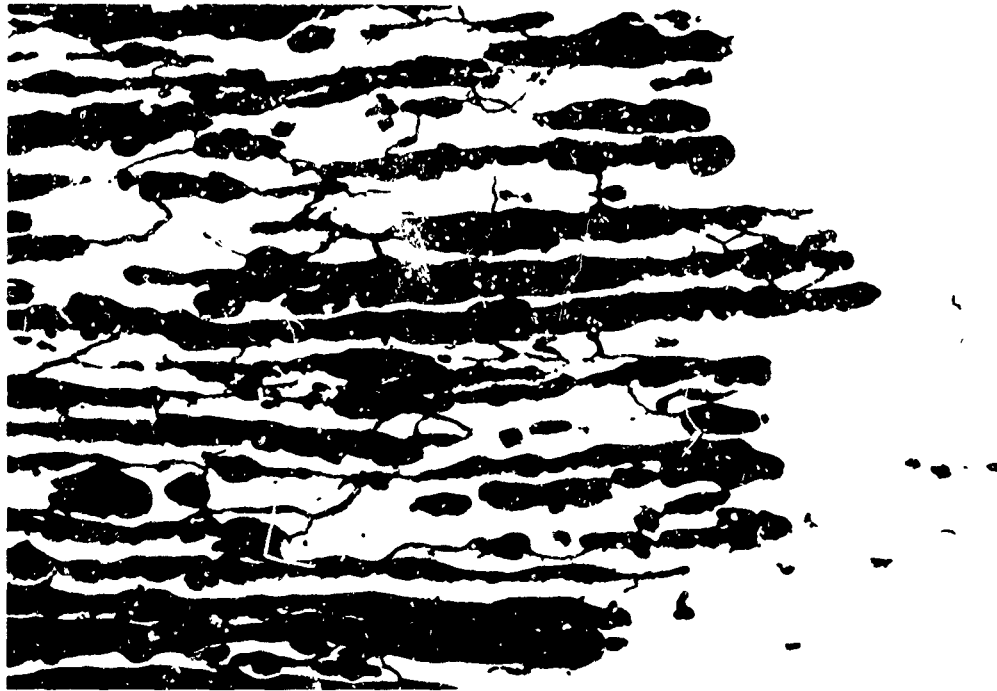
Figure 28. Edge corrosion in type 405 stainless steel showing corrosion at grain boundaries. Unetched; X100.

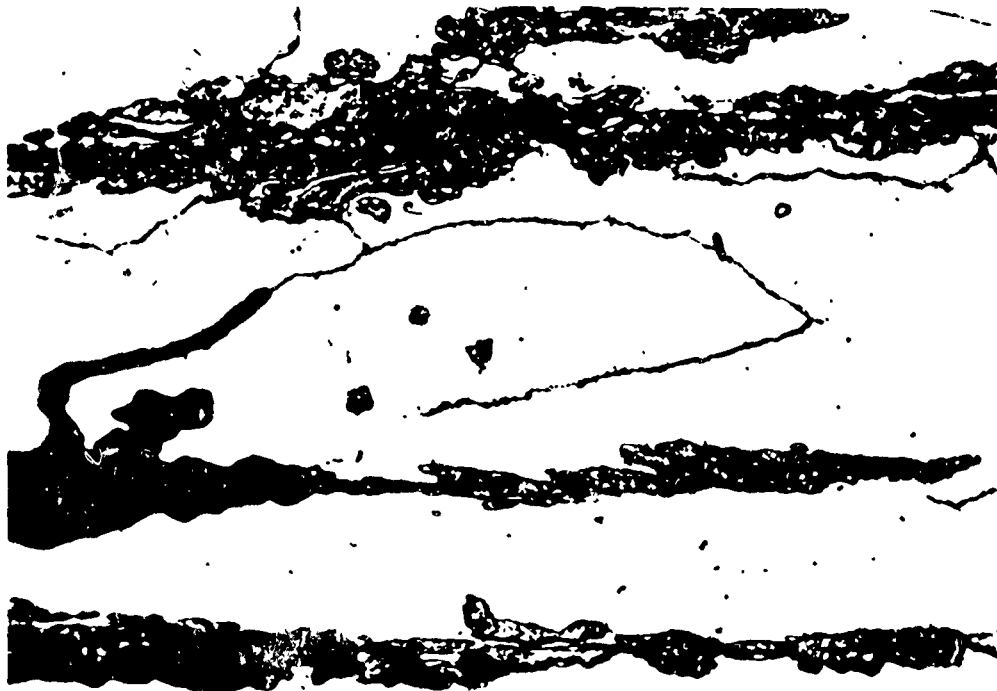
Figure 29. A portion of the area in Figure 28 showing that corrosion was along the grain boundaries and in the stringers of austenite decomposition product. Electrolytic oxalic acid etch; X500.
